FAILURE ANALYSIS OF CHROMIUM PLATED ROTOR OF DOWN-HOLE DRILLING MOTORS

Meysam Zarchi *

Islamic Azad University Dezfoul Branch, Iran

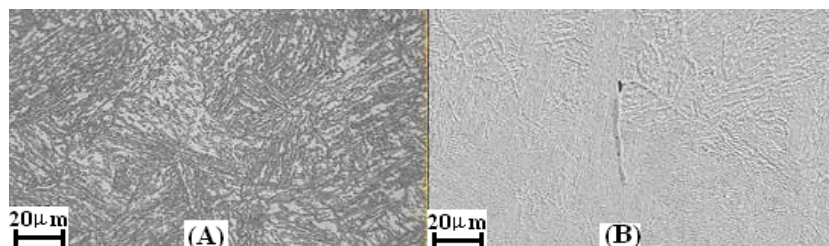
The results of the chemical analysis showed that according to AISI 630 standard this steel is of 17-4PH type which belongs to martensitic stainless steels and contains 3-5 Cu and 0.15-0.45 wt.% Nb and is hardened by copper and niobium nano-sized precipitates formed in the dendritic matrix during aging. The microstructure of this steel in aged condition is martensitic with alpha ferrite as shown in Figure 3.

Figure 3. Microstructure of rotor; A) light microscope; B) SEM.

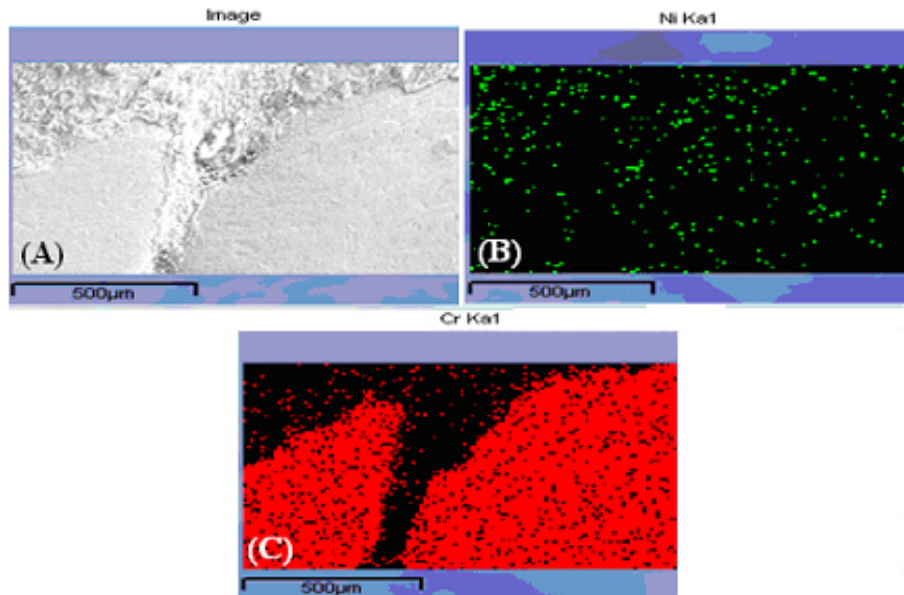
The microstructure obtained by SEM and maps of elements distribution showed that the rotor coating contained chrome, whereas the sub-layer of nickel did not exist (Figure 4).

Figure 4. SEM. Microstructure of rotor. A) failed surface; B) map of nickel distribution; C) map of chrome distribution.

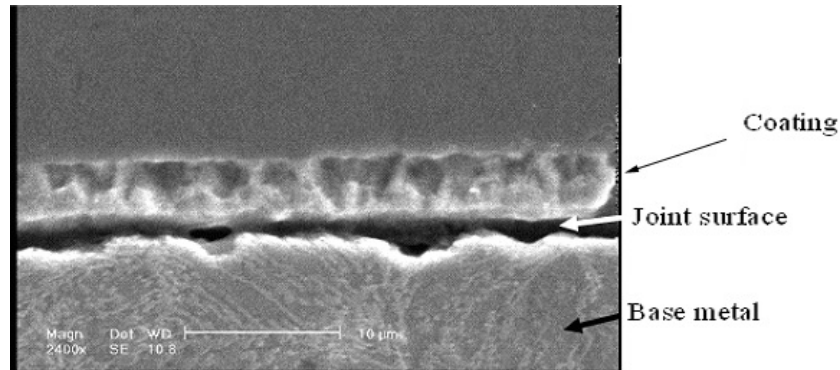
The coating thickness has been measured as 80 to 100 microns. On the other hand, the interspace between the coating and the base metal was not observed (Figure 5). This can be the reason for the lower hardness of the coating, i.e. less than 33-35 HRC. Also, coating was not continuous along its length since at different places of the rotor it has been broken due to the chemical corrosion and the process of formation of holes which in some cases has reached the sub-layer of the steel (Figure 6).

Figure 5. SEM. The cross-section of rotor with coating.

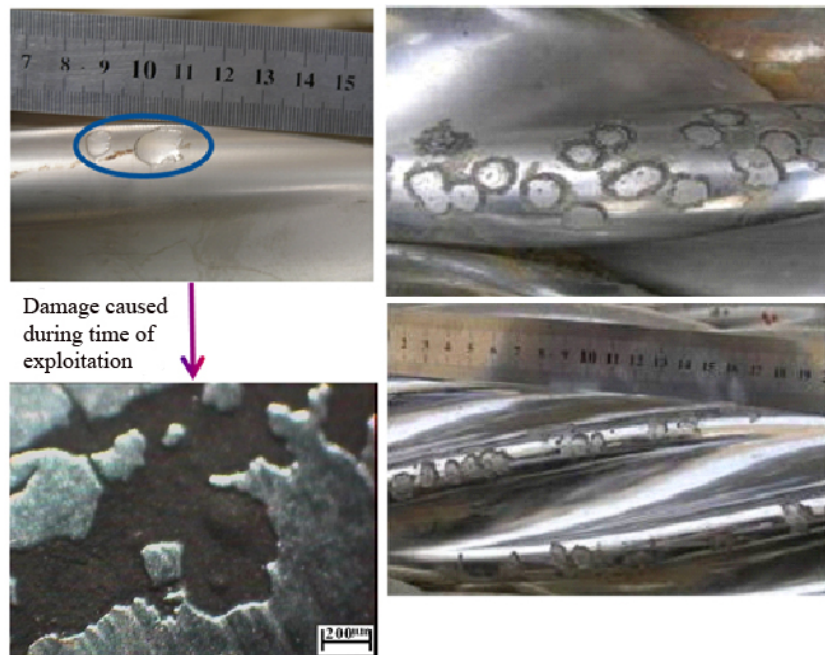
Figure 6. Macro and micrographs of the surface damage on rotor including avulsion and holes.

Formation of these holes is the result of the reaction of the steel with drilling mud containing corrosive materials like chlorides. Previous studies have shown that the hard chrome coating does not possess the necessary resistance against corrosive environments containing chloride [5]. In addition, the chemical elements and their compounds like sodium, potassium, carbon gases and hydrogen sulfide, as well as erosive particles like silica always exist in the drilling mud and their amount depends on the drilling location. It is clear that the chrome coating is always exposed to corrosive factors like these. Figure 7 shows some areas of rotor affected under the influence of

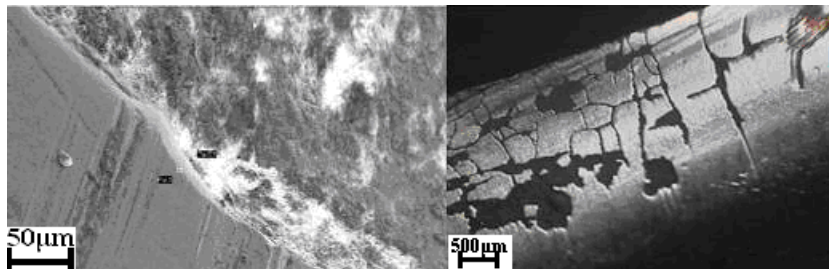
friction imposed by the pressure of drilling mud or because of the collision of hard chrome coating with solid particles existing in drilling mud. Cracks appearing mainly in the radial direction may be observed.

Figure 7. Cracks on coating due to friction.

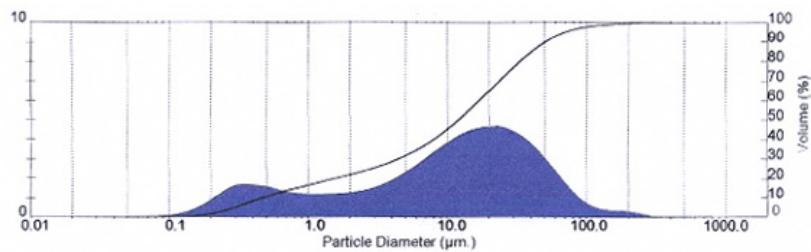
Figure 8. Distribution of the size of solid particles in drilling mud. Full line indicates the volume particles.

It may be seen that the size distribution of particles is quite irregular showing two maxima, *i.e.* one at approximately 0.3 microns (with the share of 20%) and another at approximately 20 microns (with the share of 50%), whereas particles of 300 are present in negligible amount. It may be supposed that particles with size of 20 microns are the main factor causing destruction of the rotor surface.

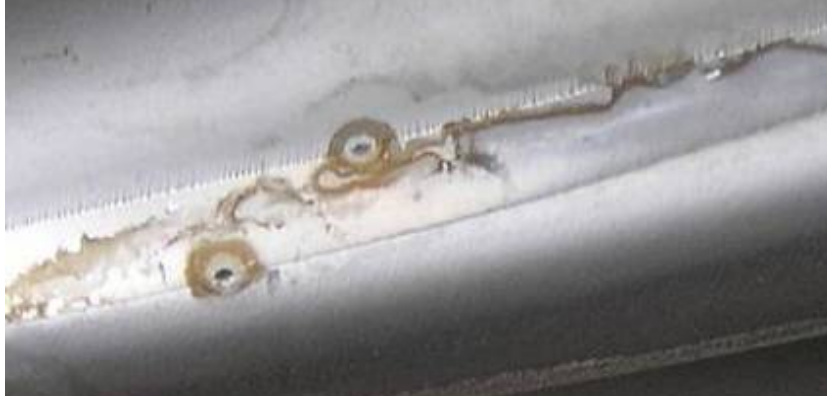
In order to solve this problem the coating of hard tungsten carbide was tried and its behavior examined [6]. However, on rotor with tungsten carbide coating failure in the form of pits as a result of corrosion may be seen in Figure 9.

Figure 9. Surface failure of rotor coated with WC. Friction cuttings and initiation of formation of pits into the base metal due to coating thinning.

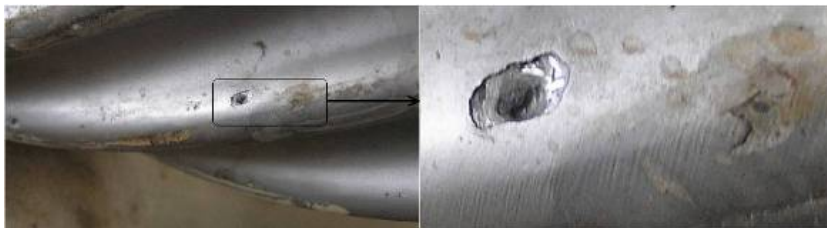
With the prolonged time of exploitation these pits may spread into the base metal causing its failure (Figure 10). Considering the results of the tungsten carbide coating, it is clear that the degree of protection has not been improved compared to the chromium coating.

Figure 10. Surface failures of rotor coated with WC. Friction cuttings and the beginning of hole penetration into the base metal due to coating thinning. The figure on the right is enlarged detail of the left figure.
