THE ROLE OF PARAMETERS CONTROLLING SERVICE LIFE OF DOWNHOLE DRILLING MOTORS POWER SECTION

Meysam Zarchi^{*}

Department of Materials and Metallurgical Engineering, Dezful Branch, Islamic Azad University, Dezful, Iran

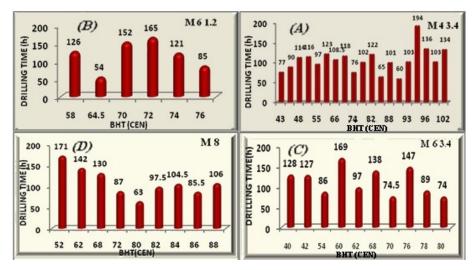
Figure 5 illustrates the effect of bottom hole temperature on rotor service life. With increase in temperature service life should acquire a descending character. Contrary to expectations exceptions in rotor service life were found in motor M 6 3.4. This motor is 6 inches in diameter and has three lobes on the rotor and four lobes on the stator.

Fig. 5 Service life of rotor as a function of changes in BHT for the same mud. A-43.4 *motor*, *B* - 6 1.2 *motor*, *C* - 6 3.4 *motor*, *D* - 8 *motor*.

With increase in temperature the gap between rotor and stator changes. Expanding of stator elastometer with temperature causes an increase of the elastometer strain which could cause elastometer destruction.

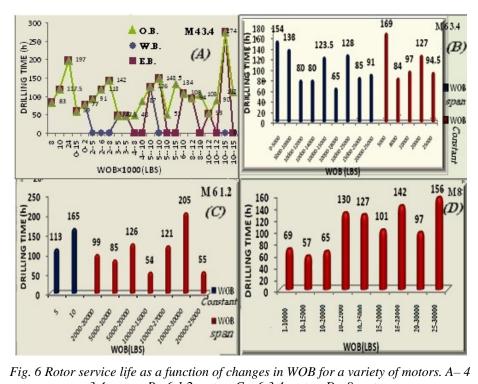
Fig. 6 Rotor service life as a function of changes in WOB for a variety of motors. A-4 3.4 motor, B - 6 1.2 motor, C - 6 3.4 motor, D - 8 motor.

Fig. 6 shows that the change in WOB does not have any particular effect on rotors of different types of motors.

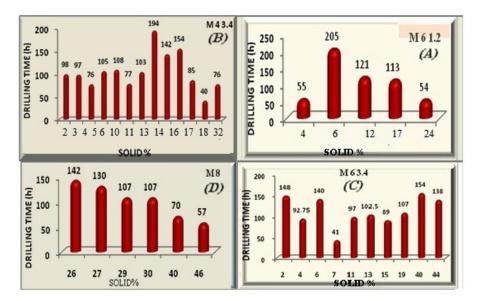
It was expected that the effect of percentage of solid particles in drilling mud will be more severe on the rotor service life than other parameters. Except rotors of M 6.1.2 and M 8 motors, increase in solid particles percentage like in the case of previously described parameters does not show any particular influence in increasing or decreasing service life (Fig. 7). This result was unexpected considering that hard and coarse solid particles in drilling mud work as hard and abrasive particles. By sticking between rotor and stator these particles form scratches and abrasive damage on the rotor surface coating. These scratches on the rotor surface coating enable the drilling fluid to reach the base metal triggering the start of the local corrosion. With advanced corrosion these areas become cavities and expanding into the base metal they generate serious damage of stator causing the motor stoppage. Thus, with increase of size of solid particles and their amount of in drilling fluid it should be expected that the service life should decrease. However, statistical analysis does not support this expectation.

Fig. 7 *Effect of the amount of solid particles in the drilling mud on the rotor service life.* A–4 3.4 motor, B - 6 1.2 motor, C – 6 3.4 motor, D - 8 motor.

The same applies to motor with 8 inches in diameter. However, this is not the same situation with other motors since decrease in the rotor life in these motors should be the influence of other parameters.

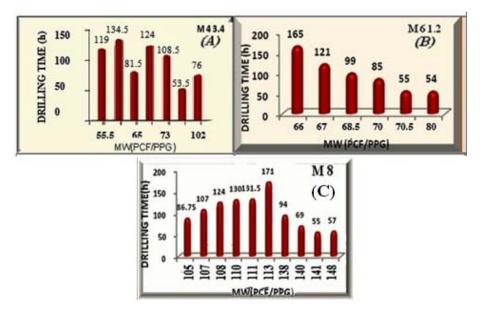
Figure 8 shows the dependence of the rotor service life on the drilling mud weight. In general, service life decreases with increase in MW. The exception of this behavior is rotor of M 63.4 motor.

Fig. 8 Rotor service life as a function of MW. A– 4 3.4 motor, B - 6 1.2 motor, C - 8 motor.
