FAILURE ANALYSIS OF JET ENGINE TURBINE BLADE

Milan T. Jovanović*, Vesna Maksimović, Ivana Cvijović-Alagić

*Department of Materials Science, Institute of Nuclear Sciences „Vinča“, 11000
Belgrade, Serbia, University of Belgrade, Serbia*

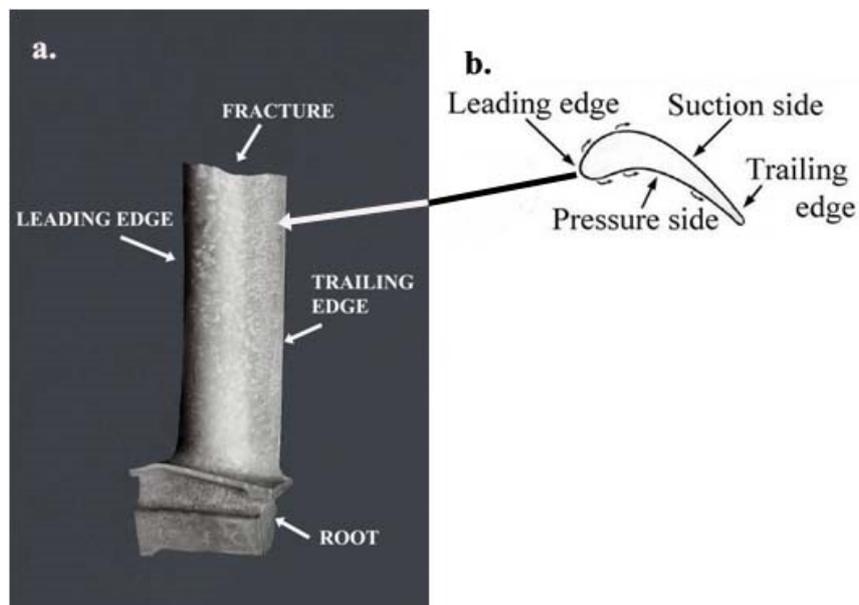
Fig. 1 a. Fractured turbine blade IN 100 of the second stage of "Viper" jet engine;
b. cross-section of aero-profile

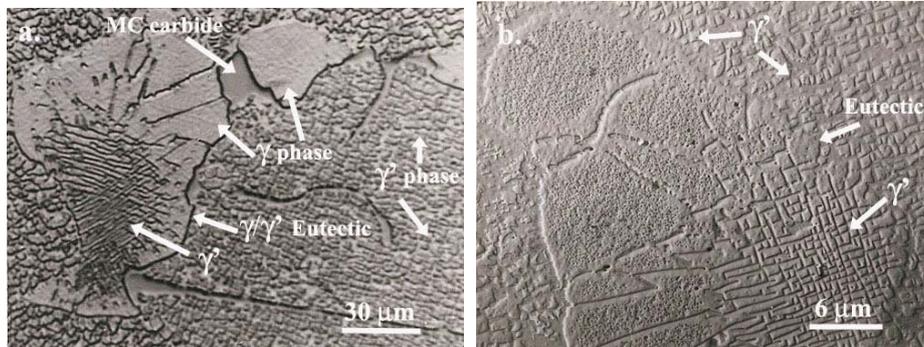
Microstructure of as-cast IN 100 turbine blade before installation in the turbine rotor, normally consists of the the matrix, which is the γ phase solid solution, small particles of intermetallic γ' phase, $\text{Ni}_3(\text{Al}, \text{Ti})$, mostly of the cuboidal shape, lamellar γ/γ' eutectic sometimes in kidney-like appearance, and primary carbides of MC type (mostly TiC) [5, 6]. This microstructure is illustrated in Fig. 1a, b.

Fig. 1 Microstructure of as-cast unused turbine blade. a. OM; b. TEM replica

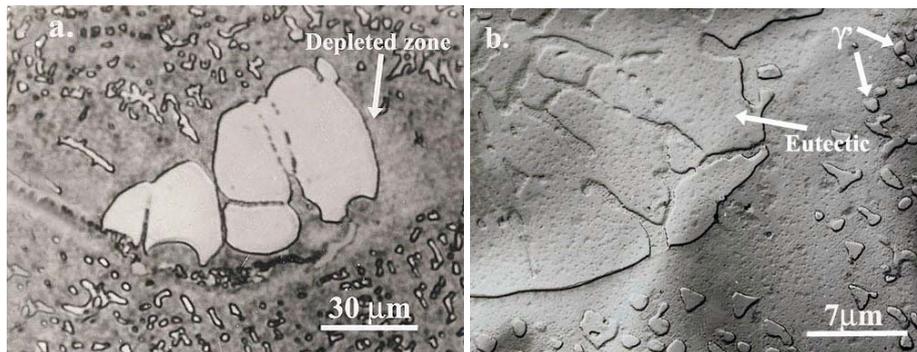
Fig. 2a, b shows microstructure of the cross-section of aero-profile taken a few millimeters below the fracture surface. The presence of all phases described in Fig. 1 may be seen, although it is quite visible that significant changes in the microstructure occurred. The volume fraction of the γ' particles was decreased, whereas they became coarser with rounded edges. Eutectics are completely depleted with the lamellar γ' phase, whereas in the surroundings of eutectics are depleted zones without any particles.

Fig. 2 Microstructure of broken turbine blade. Cross-section of a sample taken a few millimeters below the fracture surface. a. OM; b. TEM replica

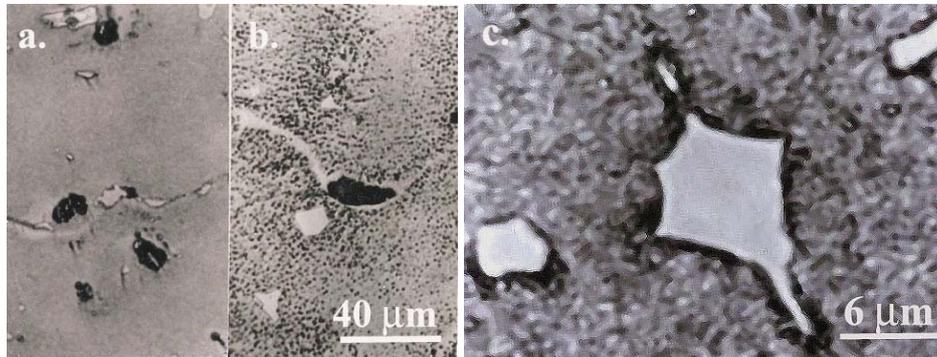
Microstructure close to the leading edge of the turbine blade (same sample as in Fig. 2) is shown in Fig. 3a. γ' particles cannot be observed in the γ matrix. Also, it is highly possible that the high temperature caused incipient melting of eutectic (black fields in Fig. 3a). On the other side, the microstructure corresponding to the root of turbine blade (Fig. 3b) shows that γ' particles, although rather small, are still present in the γ matrix. Fig. 3c which also corresponds to the microstructure of the blade root, shows primary MC carbides enveloped with the chain of γ' particles. These microstructures suggest that the temperature of blade close to the fracture area was much higher than near the blade root.

Fig. 3 Microstructure of broken turbine blade. a. OM of leading edge (same sample as in Fig. 2); b. OM of the blade root; c. TEM replica of microstructures corresponding to the blade root

Taking into account very low exploitation time, 187 h, as well as the significant changes in microstructure, it is reasonable to conclude that the turbine blade was subjected to temperatures reaching approximately 1200°C, actually the γ' phase solvus temperature. Above this temperature the entire transfer of this phase into the solid solution occurs [9]. The locations of fracture, caused by incipient melting, correspond to areas where complete dissolution of the γ' phase particles happened.

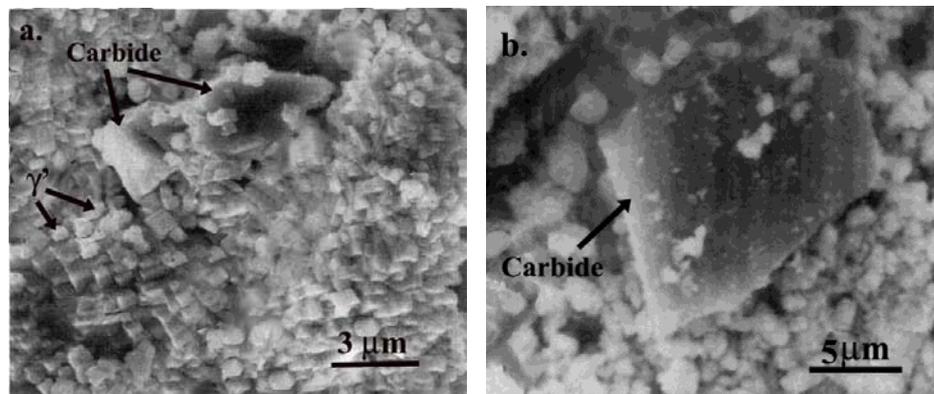
In a number of samples taken from unused turbine blade $m_{\gamma'}$ was approximately 65 wt.%, the result corresponding to the value prescribed by “Rolls Royce” for IN 100. However, the $m_{\gamma'}$ of broken blade was much smaller, ranging between 35 and 40 wt.%, depending on the location of turbine blade. Extracted powders of unused sample of turbine blade are shown in Fig. 4a. The cuboidal shape of γ' particles are present in extracted material together with plate-like and blocky MC carbides. The size of γ' particles is approximately 0.3 μm. Extracted powders close to the fracture surface are smaller with less cuboidal form and with rounded edges (Fig. 4b).

Fig. 4 SEM. Extracted powders from turbine blade. a. From unused turbine; b. close to fracture surface
