CORROSION OF STEELS INDUCED BY MICROORGANISMS

Biljana S. Maluckov*

*Technical Faculty in Bor, University of Belgrade, Vojske Jugoslavije 12, 19210
Bor, Serbia*

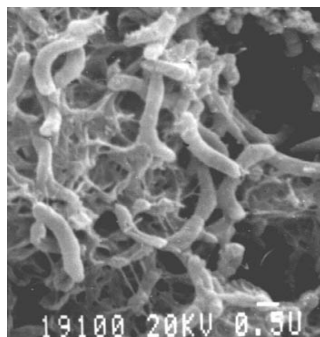
Fig. 3. Biofilm formed by sulfate-reducing bacteria on the surface of mild steel, visualized using SEM [6].

Mild steels are steels with the low carbon content. The mild steels and carbon steels are also broadly used in industry. The main triggers of corrosion of these steels are sulfate reducing bacteria (Fig 3.). The SRB types show considerable adaptability to extreme conditions. Among them the SRB, *Desulfovibrio sp.* can be relatively easily isolated and purified [22].
